# What is **E-Safe**<sup>©</sup>?

# E-Safe® Trial Treatment Reports

# Trial at Egmanton Central Well Site

The application of E-Safe® in the treatment of contaminated land

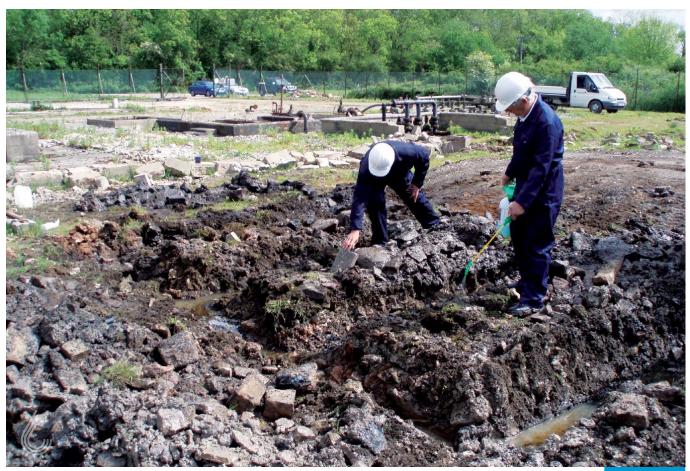
Figure 1

The site has been used for over fifty years as a central depot for collecting the crude oil from surrounding wells. The site has been disassembled and Star Energy organized a full land survey to determine the degree of contamination of the soil. (Plutus are to receive a copy of the report). One of the most contaminated areas was selected for the trial and this area was prepared for the application of the products (see figure 1).

The selected area for treatment was the most contaminated of the three areas on the site. (Figure 1). The area was prepared by excavating three piers of approximately 1m x 1.5m. The piers were very stony and it was decided to treat a 1m square area of each pier. As mentioned earlier the ground was very wet and the area quickly filled with surface water and contaminated oil. On close inspection it was assumed that due to the clay subsoil there would have been little existing microbial activity (if any) on the site as the area is effectively sealed and any microbes present that could breakdown oil would have been overwhelmed by the amount of oil present.

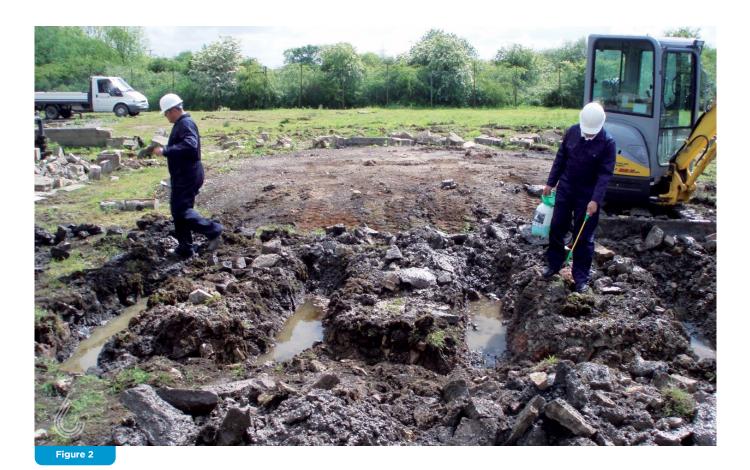
The excavation revealed a large amount of water had seeped into the trench (see figure 2). Concerns were raised as to the affect the high volume of water and oil could have on the proposed treatment areas. The sub soil is a clay base so the liquid contained within the trenches could only evaporate and slowly disperse. The area is also heavily impregnated with stone and this resulted in difficulties in preparing the trial area and may affect the outcome as well as the treatment itself. There is a risk that the individual trial sites could not be isolated and therefore they could be re-contaminated by oil and water from the surrounding areas leaching into the trial areas resulting in inaccurate data.

The prepared area was divided into three separate piers (see figure 2) and the following treatments were applied;
